THERMOGRAPHY

Sector: Marine / Port dredging.

Asset: Pumping system and auxiliary power system of a suction dredger, focused on two critical subsystems:

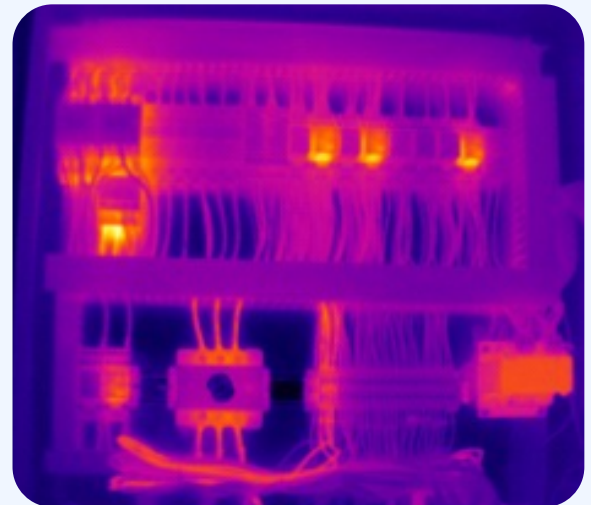
- Inspection planning: definition of critical assets, minimum load conditions for capture, and safe access routes in the electrical room and engine room.
- Thermal and visual image acquisition: in-operation inspection of the low-voltage board, power terminals, contactors, protective devices, and the housing of the hydraulic motor. Radiometric images were used to compare phases, equivalent connections, and like-for-like components.
- Comparative analysis: evaluation of thermal differentials between phases and similar points. A localized hot spot was identified at an output connection of the main contactor, with an estimated maximum temperature of 118 °C, compared with equivalent connections between 62 and 68 °C. An area of abnormal heating was also observed on the motor coupling-side bearing, approximately 18 °C above the opposite side.

- Technical diagnosis: the thermal signature was consistent with high contact resistance at an electrical terminal, probably promoted by loosening, oxidation, and the saline environment. In the motor, the thermal pattern suggested mechanical friction and early-stage lubrication degradation, with insufficient evidence to conclude severe winding damage.
- Intervention recommendation: tightening and remediation of connections, cleaning and reconditioning of the affected electrical point, torque verification, phase-load review, and planned corrective maintenance of the motor, including bearing inspection and controlled relubrication.
