LASER ALIGNMENT

Sector: Food and Beverage

Asset: 132 kW motor + gearbox + main drying fan, with belt drive at the final stage. This is a critical assembly for the operational continuity of the process, since any loss of mechanical stability in the train directly affects drying capacity, maintenance planning, and the risk of unplanned shutdown.

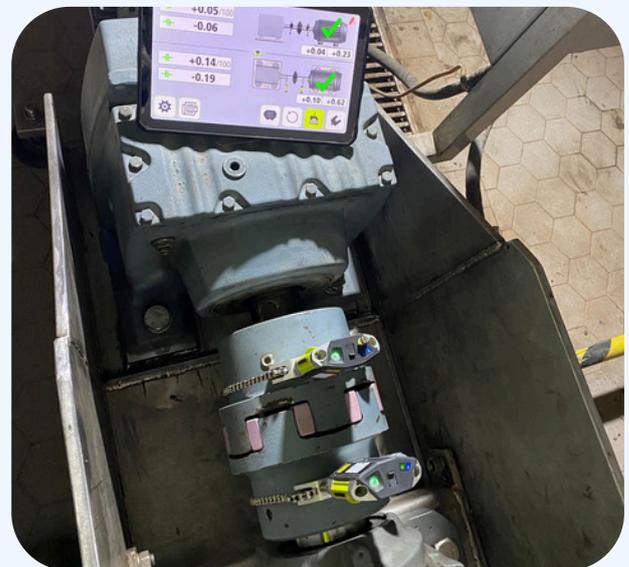
During the review, it was identified that the degradation was not due to a single isolated element. The findings showed a combination of geometric and mechanical deviations that explained the abnormal stress on the train:

- Soft foot on one of the motor's rear feet.
- Angular misalignment at the motor–gearbox coupling.
- Pulleys out of coplanarity and uneven tension between belts.
- Secondary signs of accelerated wear associated with lateral transmission stress.

- Laser alignment of the motor–gearbox assembly, correcting angular and parallel deviations.
- Laser pulley alignment on the belt drive, verifying the actual coplanarity of the system.
- Soft foot verification, with correction by adjusting supports and shims.
- Inspection of base condition and anchor tightening, to ensure mechanical stability and repeatability of the adjustment.
- Belt tension check, correcting load irregularities between belts.
- Recording of the initial and final condition, leaving a reference of verified tolerances for subsequent follow-up.
