PHOTOVOLTAIC INSPECTION

Sector: Renewable energy generation – utility-scale photovoltaic.

Asset: Photovoltaic plant of approximately 20–50 MWp, composed of solar modules, string inverters, string combiner boxes, and the associated DC cabling network. It is considered a high-criticality asset due to its direct impact on production, electrical safety, and plant availability.

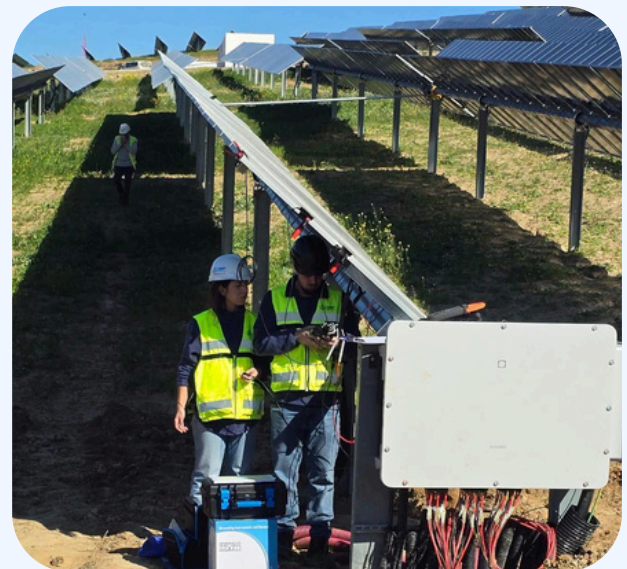
- Modules with localized hotspots consistent with damaged cells or persistent localized shading.
- DC connectors and terminals with overheating compared to equivalent circuits, indicating high contact resistance.
- Blown or degraded fuses in string combiner boxes, with partial or total loss of contribution in some branches.
- Imbalance among strings connected to the same inverter, associated with uneven degradation, poor connections, or severe localized soiling.
- Thermal derating events in inverters, linked to poor ventilation, internal dirt buildup, or high ambient temperature combined with sustained load.
