LASER ALIGNMENT

Sector: Food and Beverage

Asset: 132 kW motor + gearbox + main drying fan, with belt drive at the final stage. This is a critical assembly for the operational continuity of the process, since any loss of mechanical stability in the train directly affects drying capacity, maintenance planning, and the risk of unplanned shutdown.

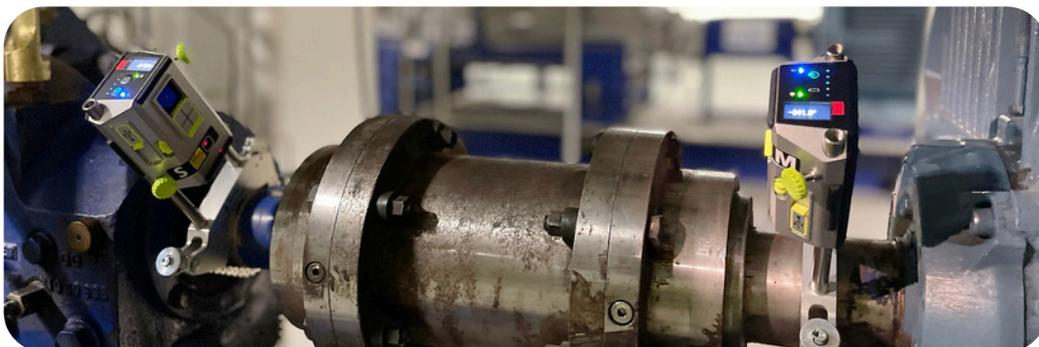
- Reduction in overall vibration of the assembly: 25–45%.
- Temperature decrease at the critical support: 8–15 °C under steady-state conditions.
- Estimated increase in belt service life: 1.5 to 2.5 times.
- Decrease in corrective incidents in the train: 30–50% in subsequent operating cycles.
- Expected improvement in maintenance planning: lower recurrence of non-resolving replacements and better traceability of mechanical condition
