## VIBRATION ANALYSIS

**Sector:** Power generation

**Asset:** Main cooling pump driven by a medium-voltage electric motor. Critical equipment for plant operational continuity, with high availability requirements and minimal margin for unplanned shutdowns.

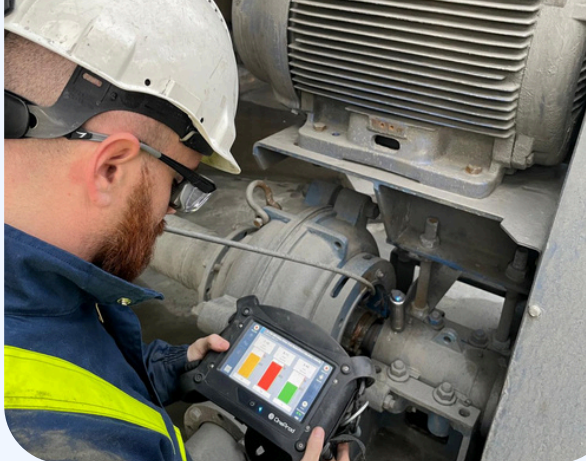
- Review of the measurement route and validation of acquisition points at both motor and pump bearings/supports.
  - Capture and analysis of FFT spectra, time waveform, and historical vibration trend.
  - Comparison of the dynamic signature of the motor-pump assembly between the non-drive end and the drive/coupling end.
  - Correlation of vibration data with the equipment load and operating condition.
-

- Evaluation of spectral components associated with misalignment, mechanical harmonics, looseness, and incipient bearing defects.
  - Issuance of a technical diagnosis with a recommendation for action during a scheduled shutdown.
  - Specific recommendation to verify alignment, correct the base condition, and perform post-startup verification to validate the effectiveness of the intervention.

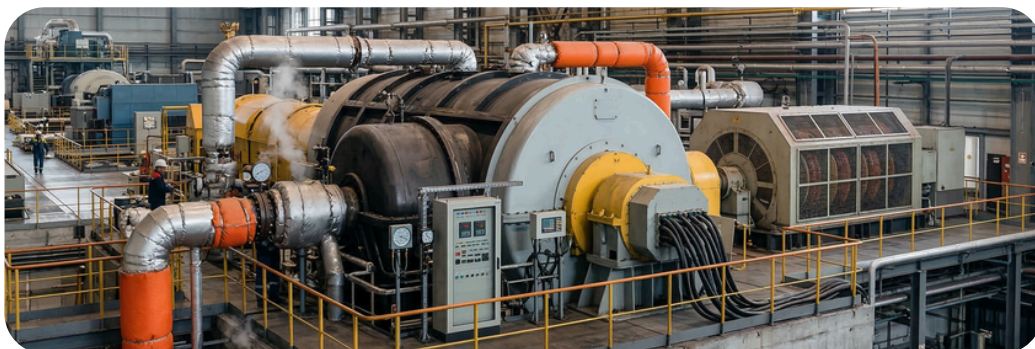
- Estimated reduction in overall assembly vibration: 35–60%.
- Estimated temperature decrease at the coupling-side support: 10–20%.
- Estimated extension of the service life of the replaced/corrected bearing: 20–40%.
- Probable avoidance of an unplanned shutdown of critical equipment.
- Reduction in potential intervention cost by converting an emerging failure into a scheduled correction.

- The analysis showed a combination of symptoms: predominance of components consistent with misalignment, presence of mechanical harmonics, and increased energy in the high-frequency band, consistent with the onset of bearing deterioration. Additionally, the dynamic response suggested slight base looseness, which could amplify the vibratory behavior of the assembly.
- During the scheduled shutdown, the inspection confirmed alignment deviation outside tolerance and premature bearing wear at the affected support, validating the previously issued diagnosis.
