ULTRASOUND

Sector: Petrochemical.

Asset: Process steam line with a float and thermostatic steam trap installed at a critical heating point. Medium-high criticality asset due to its impact on energy efficiency, process thermal stability, and the risk of condensate not being properly managed.

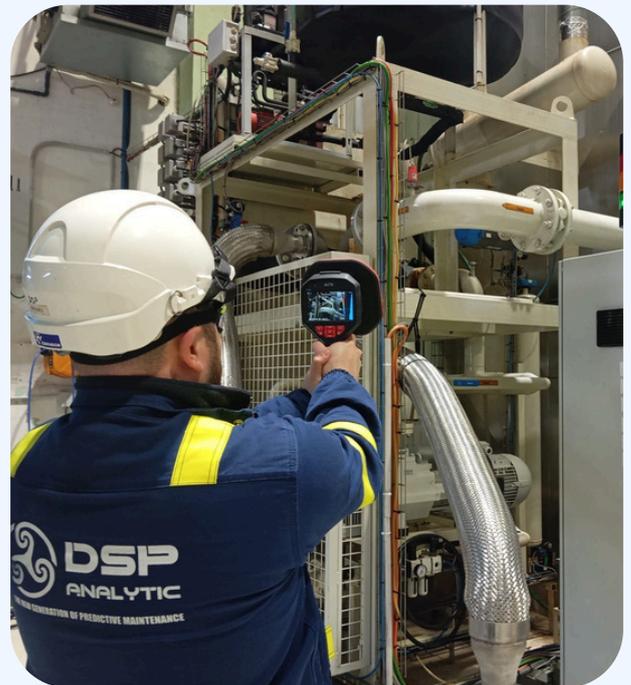
- Field survey: the trap was inspected in operation, together with upstream and downstream points.
- Ultrasonic acquisition: the signal was captured by contact to identify the acoustic discharge pattern.

- Condition analysis: signal continuity and its behavior relative to the expected cycle for this type of trap were evaluated.
- Technical validation: the finding was correlated with the equipment function, process conditions, and the thermal behavior observed in the line.

- Diagnosis: a condition consistent with internal live steam leakage was determined, because the ultrasonic signature showed sustained flow rather than a normal opening/closing or modulation cycle.

- Recommendation: planned replacement of the trap was prioritized during the next maintenance window to avoid continuous energy loss and potential impact on the system.

- Follow-up: expanding the inspection to the complete circuit was recommended in order to detect similar failures and establish a periodic ultrasound route.
